Shear Bond Strength of Bulk-fill Resin Composite after Bur and Air Abrasion Surface Treatments

Peerapong Kupradit¹, Sirinporn Anuntasirichinda², Bantita Kanpittaya², Chantalak Chareonwichienchai²
¹Department of Restorative Dentistry, Faculty of Dentistry, Khon Kaen University, Khon Kaen, Thailand
²Sixth Year Dental Student, Faculty of Dentistry, Khon Kaen University, Khon Kaen, Thailand

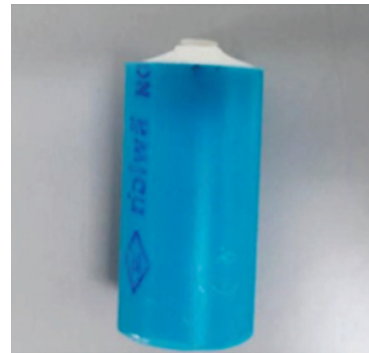
Figure 1: Side view of a specimen showing 1 mm of the top surface with emerging resin composite.

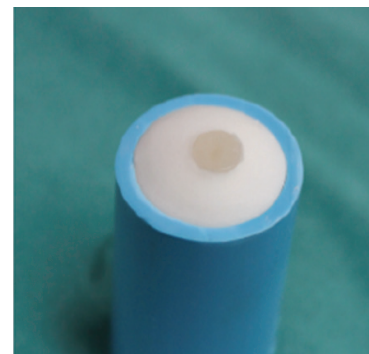
Figure 2: Top view of cylindrical specimens fabricated with acrylic resin at the center of PVC tube.

Mounting specimen with PVC tube: Plaster of Paris was mixed and poured into a PVC tube (external

diameter 22 mm; internal diameter 17 mm; height 40 mm). The plaster was poured into the tube to about three-quarters full and left for one hour to set. Acrylic resin powder and monomer were mixed until viscous and poured over the hardened plaster in the PVC tube. The mixture of acrylic slightly overflowed the rim of the PVC tube. The specimen was placed leaving the marked side down: 1 mm of material emerged from the acrylic (Figure 1) at the center of the PVC tube (Figure 2). When the acrylic was hardened, the specimen was rinsed with water from 5 cm away using a triple syringe for 30 seconds. Finally, the specimen was blow-dried.

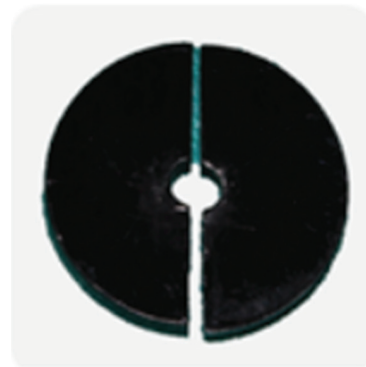
Figure 3: Acrylic split mold show interior diameter 3 mm and height 3 mm.

(compositions shown in Table 1) and slightly blown for 5 sec. The specimen was exposed to curing light for 20 sec. Split molds of cylindrical specimens were placed on the semicircle (exterior diameter 22 mm, interior diameter 3 mm, and height 3 mm (Figure 3). The specimens after

A problem discovered during the study was that sometimes when parts of the restorative materials were being treated, the two parts did not always adhere to each other. This observation was probably due to the acrylic split mold, which would cause adhesion failure during movement. The problem can be prevented by fixing the mold tightly to restrict movement during the treatment, and the acrylic split mold design needs to be improved to

provide better stability.

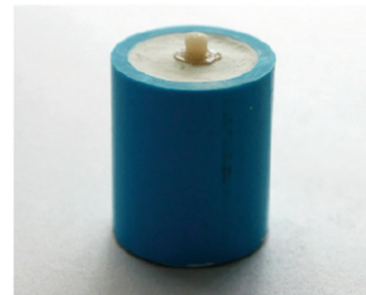
Figure 4: Top view of specimens after repair with resin composite height 3 mm.

being repaired with resin composite are 3 mm of repaired resin composite. The specimens in Groups A, B, and C were randomly divided into two subgroups. Each subgroup had ten specimens—all specimens were divided into six groups (Figure 5).

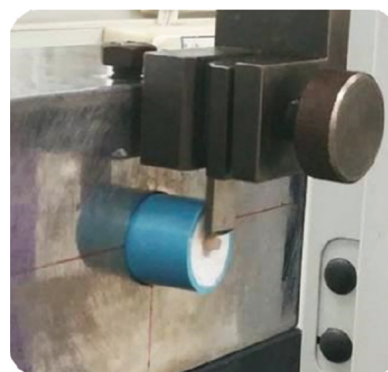
Figure 6: Side view of specimen on the Universal Testing Machine. The tip of the wedge is set at the interface between the old and repaired resin composite.

Shear Bond Strength Testing: All six groups repaired with resin composite were mounted on a universal testing machine (Universal Testing Machine. LLOYD model LR 30 K. Lloyd Instruments Ltd., Hants, England) by setting the test speed at 0.5 mm/sec and the tip of the wedge at the interface between the old and repaired resin composite (Figure 6). We recorded the moment (shear bond strength in MPa) when adhesive strength failed^(7,13,14). The tested

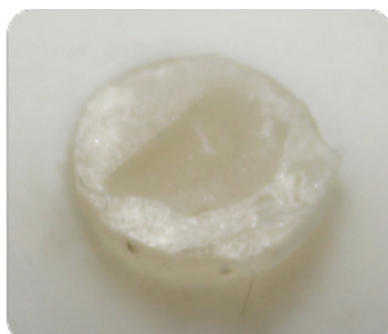
Figure 7: Top view of specimen cohesive failure shows crack depth within resin composite.

Comparison of shear bond strength with surface treatment analyzed using the Kruskal Wallis Test at 0.05 significance indicated that at least one pairing exhibited differences. The couples that showed statistically significant differences ($p < 0.001$) were groups 1 and 5, 3 and 5, 2 and 6, and 4 and 6. There was no significant difference between groups 2 and 4 ($p = 0.94$). Comparison of shear bond strength on different types of restorative material analyzed using the Mann Whitney test at 0.05 significance indicated a significant difference between groups 1 and 2 ($p = 0.001$) and 3 and 4 ($p = 0.019$). There was no significant difference between groups 5 and 6 ($p = 0.762$). The study of fracture failure by investigating in stereomicroscope found crack depth within resin composite or cohesive failure (Figure 7). Adhesive de-bonds from the interface of resin composite or adhesive failure

(Figure 8). The results of fracture failure are presented in Table 3. All specimens in groups 2 and 4 had cohesive failure, while all specimens in groups 5 and 6 had adhesive failure. In groups 1 and 3, both cohesive and adhesive failure occurred.
